# LUIZ MUÑOZ MARÍN INTERNATIONAL AIRPORT PROJECT, CAROLINA, PUERTO RICO

## Drainage Study

March 2019

D140599.00

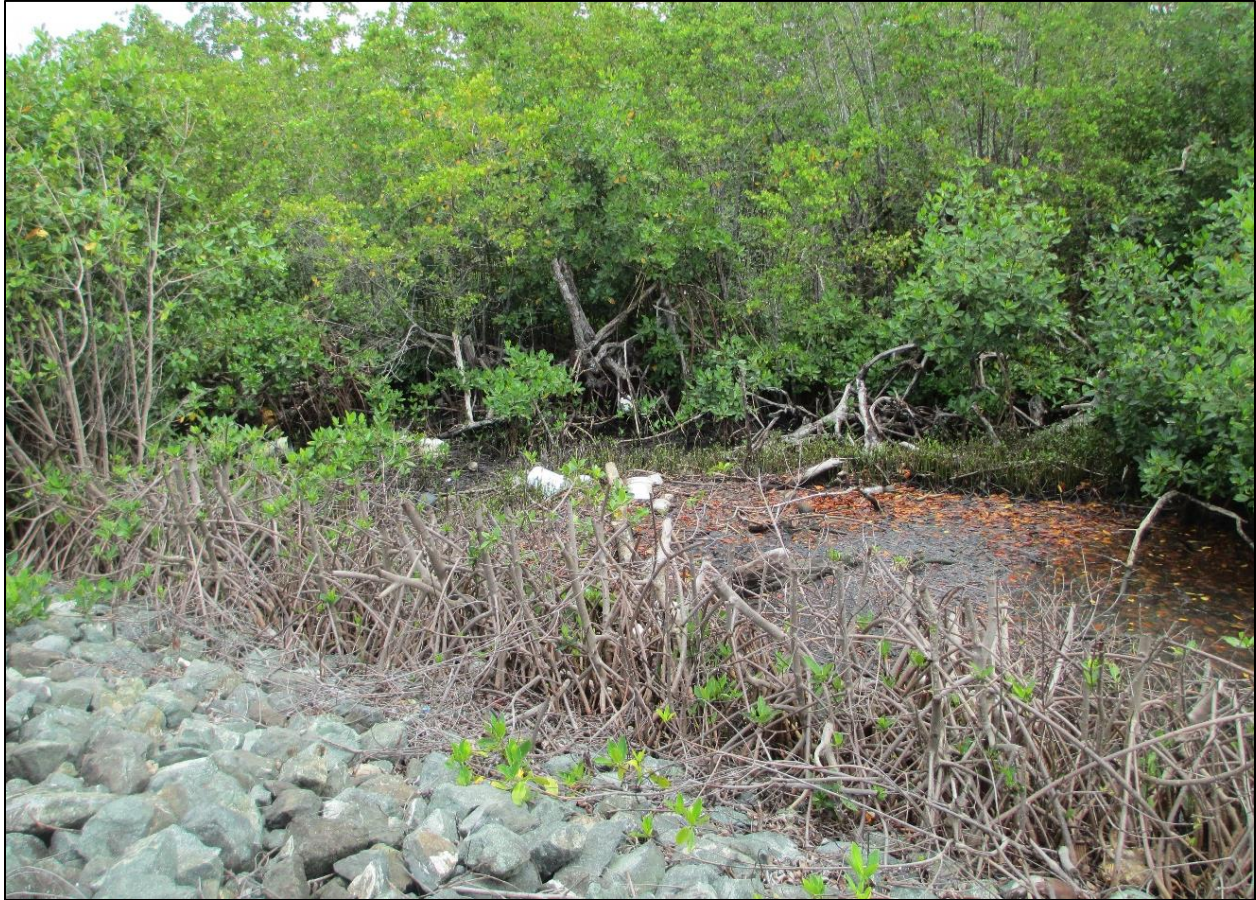
**Photo 1**  
Mangrove encroachments in Channel A.

Many of the open water channels are populated by significant mangroves which encroach upon the channel, and in some cases spread across the entire channel (Photo 1). Field observations and measurements indicate that approximately 2 feet of sediment has accumulated along the channel bottoms. This sediment is likely deposited from airport runoff, inflow from tidal flows, and from decaying organic matter within the channels themselves. Sediment and vegetation has partially filled many of the culverts which connect the open water channels as well as some of the stormwater pipes that discharge to the channel system.

ESA engineers observed that many of the drainage channels are heavily encroached with mangrove trees. The mangrove vegetation increases the roughness of these channels, likely contributes to sediment accumulation, and inhibits maintenance of the channels by airport staff.

- **Alternative A** model results simulating cleaning channels and culverts of sediment, vegetation, and obstructions predict reduced water surface elevations and reduced frequency of flooding in the channel system under normal tidal conditions.

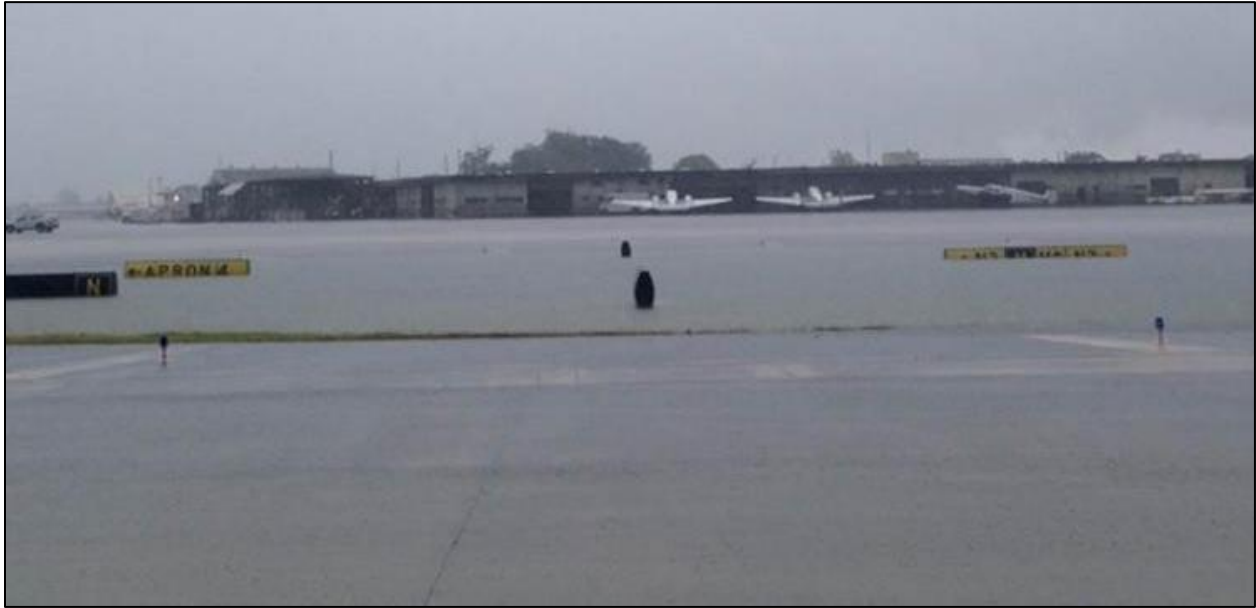
**Photo 2**  
Flooding overtopping lights and signs.

Flooding has been a persistent problem at various locations throughout the airport. Known problem flooding areas at the airport are shown in Figure 4. These areas were identified based on conversations and information provided by airport staff. Photos of historical flooding events were provided to the team by Aerostar (Photo 2 and Photo 3).

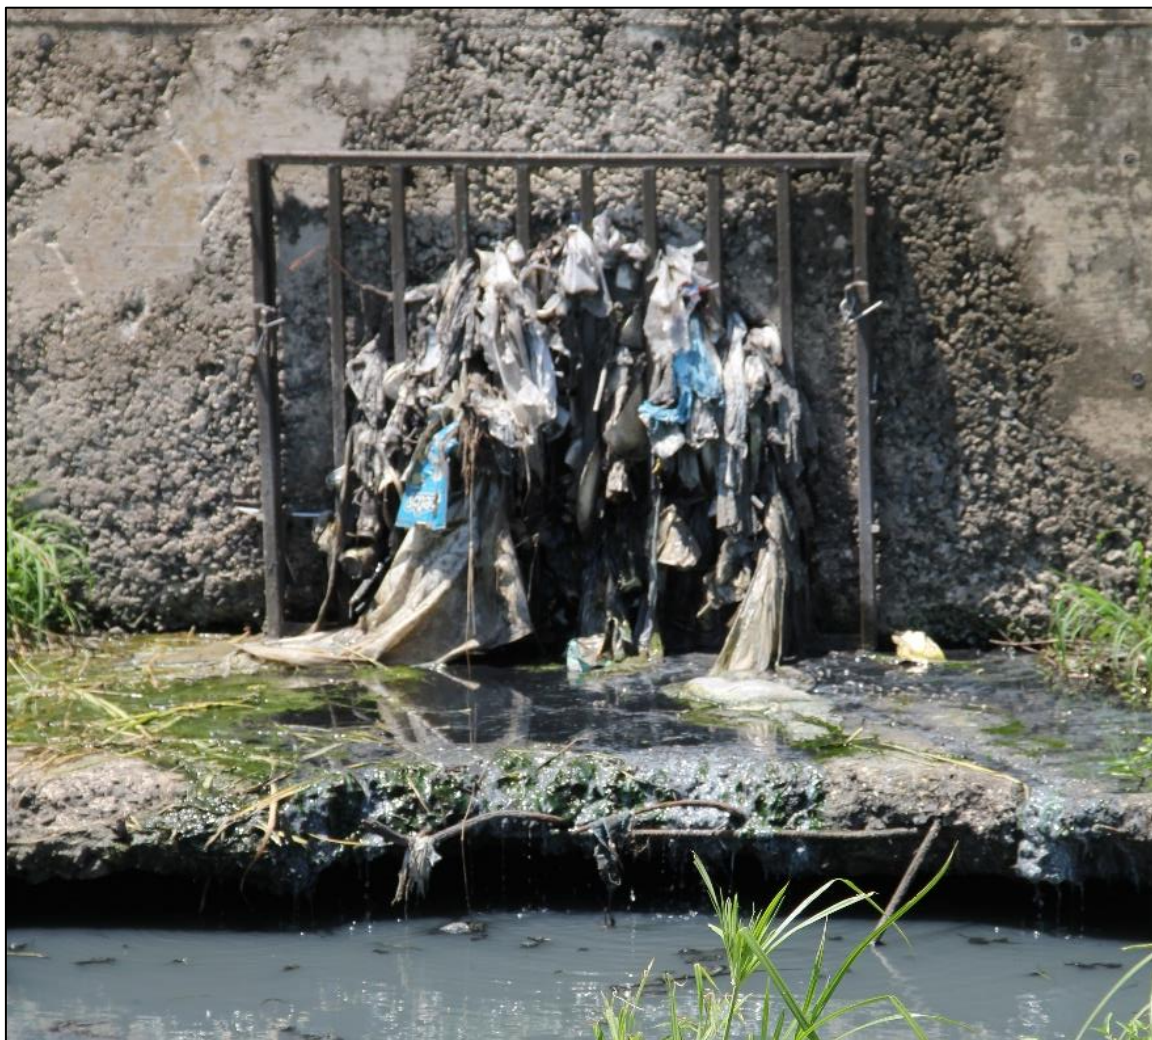
**Photo 5**  
Clogged sanitary drain discharging into airport.

During the field investigations of the site, the project team identified an outfall that originates from off-site and discharges to the channel at the south of the airport. The location of this outfall is identified on Figure 3. ESA observed a smell and buildup of trash at the outfall that indicates that this outfall is discharging sanitary sewer waste to the airport site (Photo 5). The discharge from the outfall is coming from the neighborhood to the south. It is unclear if the sanitary sewer contamination is the result of a direct connection or a consequence of failing pipes within the sewer system and inflow and infiltration into the off-site drainage system.
