# LUIZ MUÑOZ MARÍN INTERNATIONAL AIRPORT PROJECT, CAROLINA, PUERTO RICO

## Drainage Study

March 2019

D140599.00

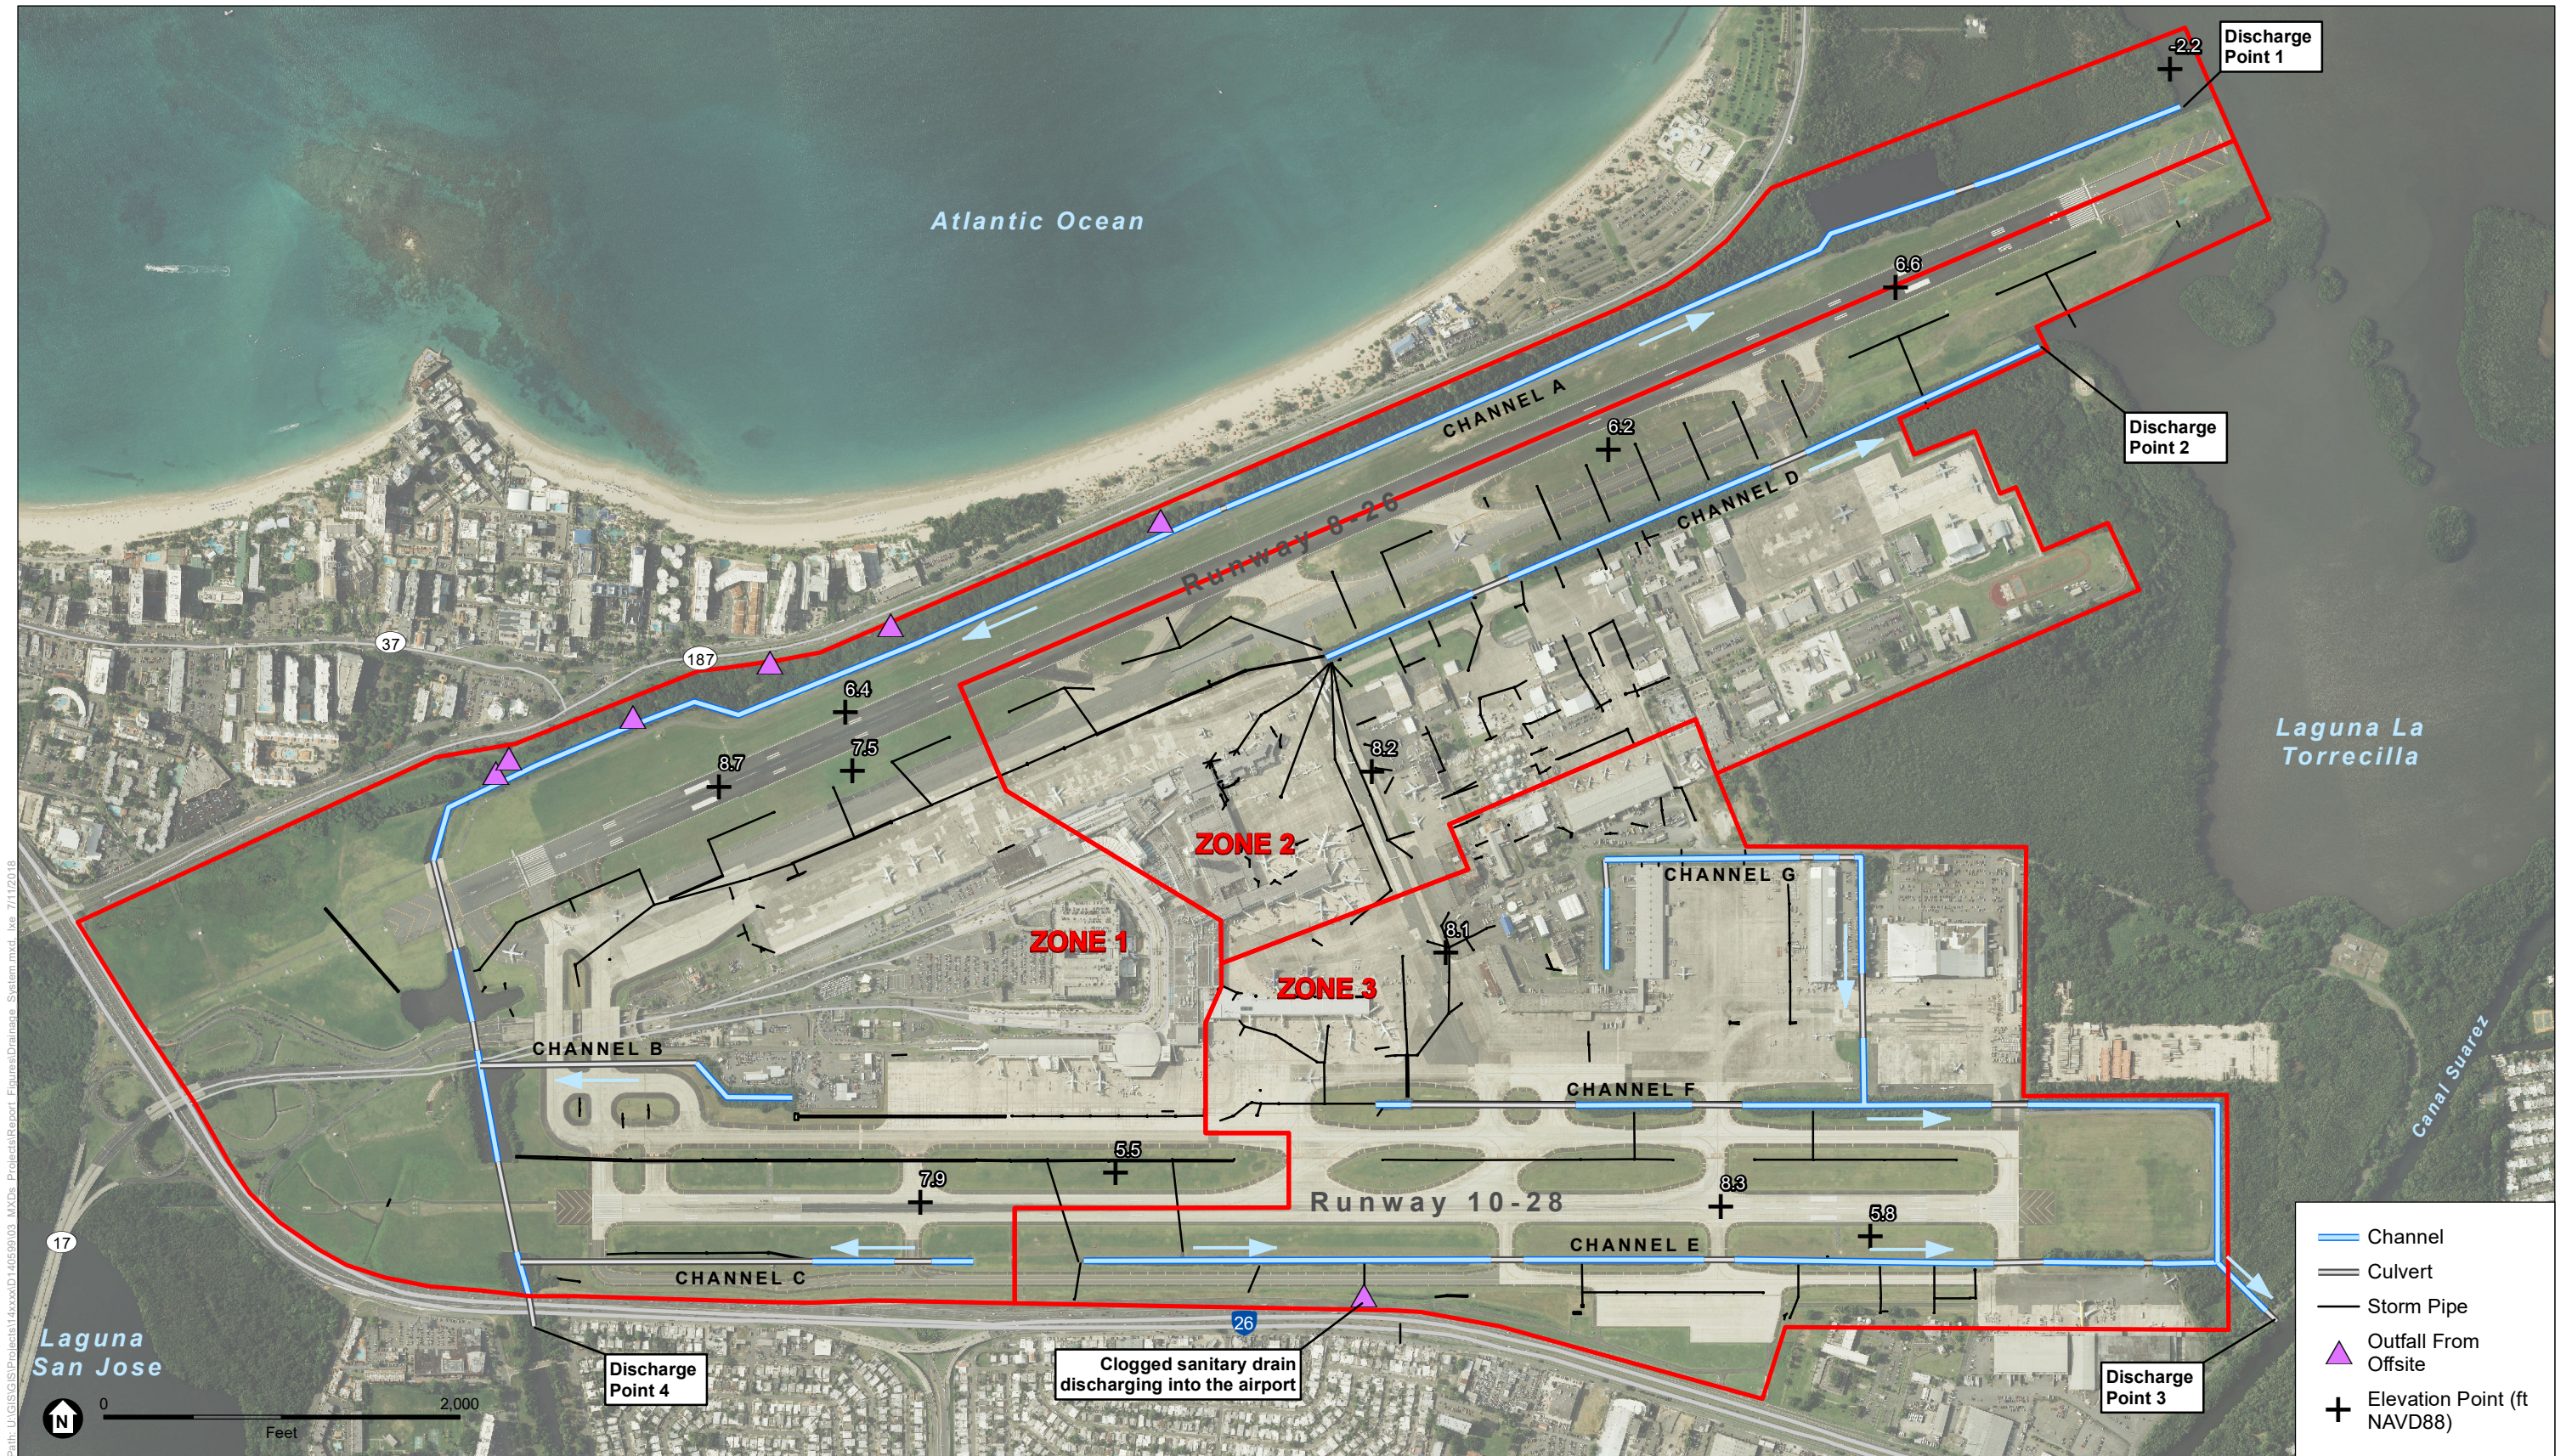
Many of the open water channels are populated by significant mangroves which encroach upon the channel, and in some cases spread across the entire channel (Photo 1). Field observations and measurements indicate that approximately 2 feet of sediment has accumulated along the channel bottoms. This sediment is likely deposited from airport runoff, inflow from tidal flows, and from decaying organic matter within the channels themselves. Sediment and vegetation has partially filled many of the culverts which connect the open water channels as well as some of the stormwater pipes that discharge to the channel system.

**Photo 1**  
Mangrove encroachments in Channel A.

ESA engineers observed that many of the drainage channels are heavily encroached with mangrove trees. The mangrove vegetation increases the roughness of these channels, likely contributes to sediment accumulation, and inhibits maintenance of the channels by airport staff.

Vegetation encroachment in the drainage channels as well as sediment deposition in the channels and pipes were observed to be impeding drainage efficiency in the study area. Alternative A consists of removing vegetation in the channels, dredging two feet of accumulated sediment from the bottom of all channels, clearing sediment and obstructions from all interconnecting pipes, and replacing an undersized 24-inch pipe with two 42-inch pipes (link between node “XS23” and node “XS25”) (Figure 7).

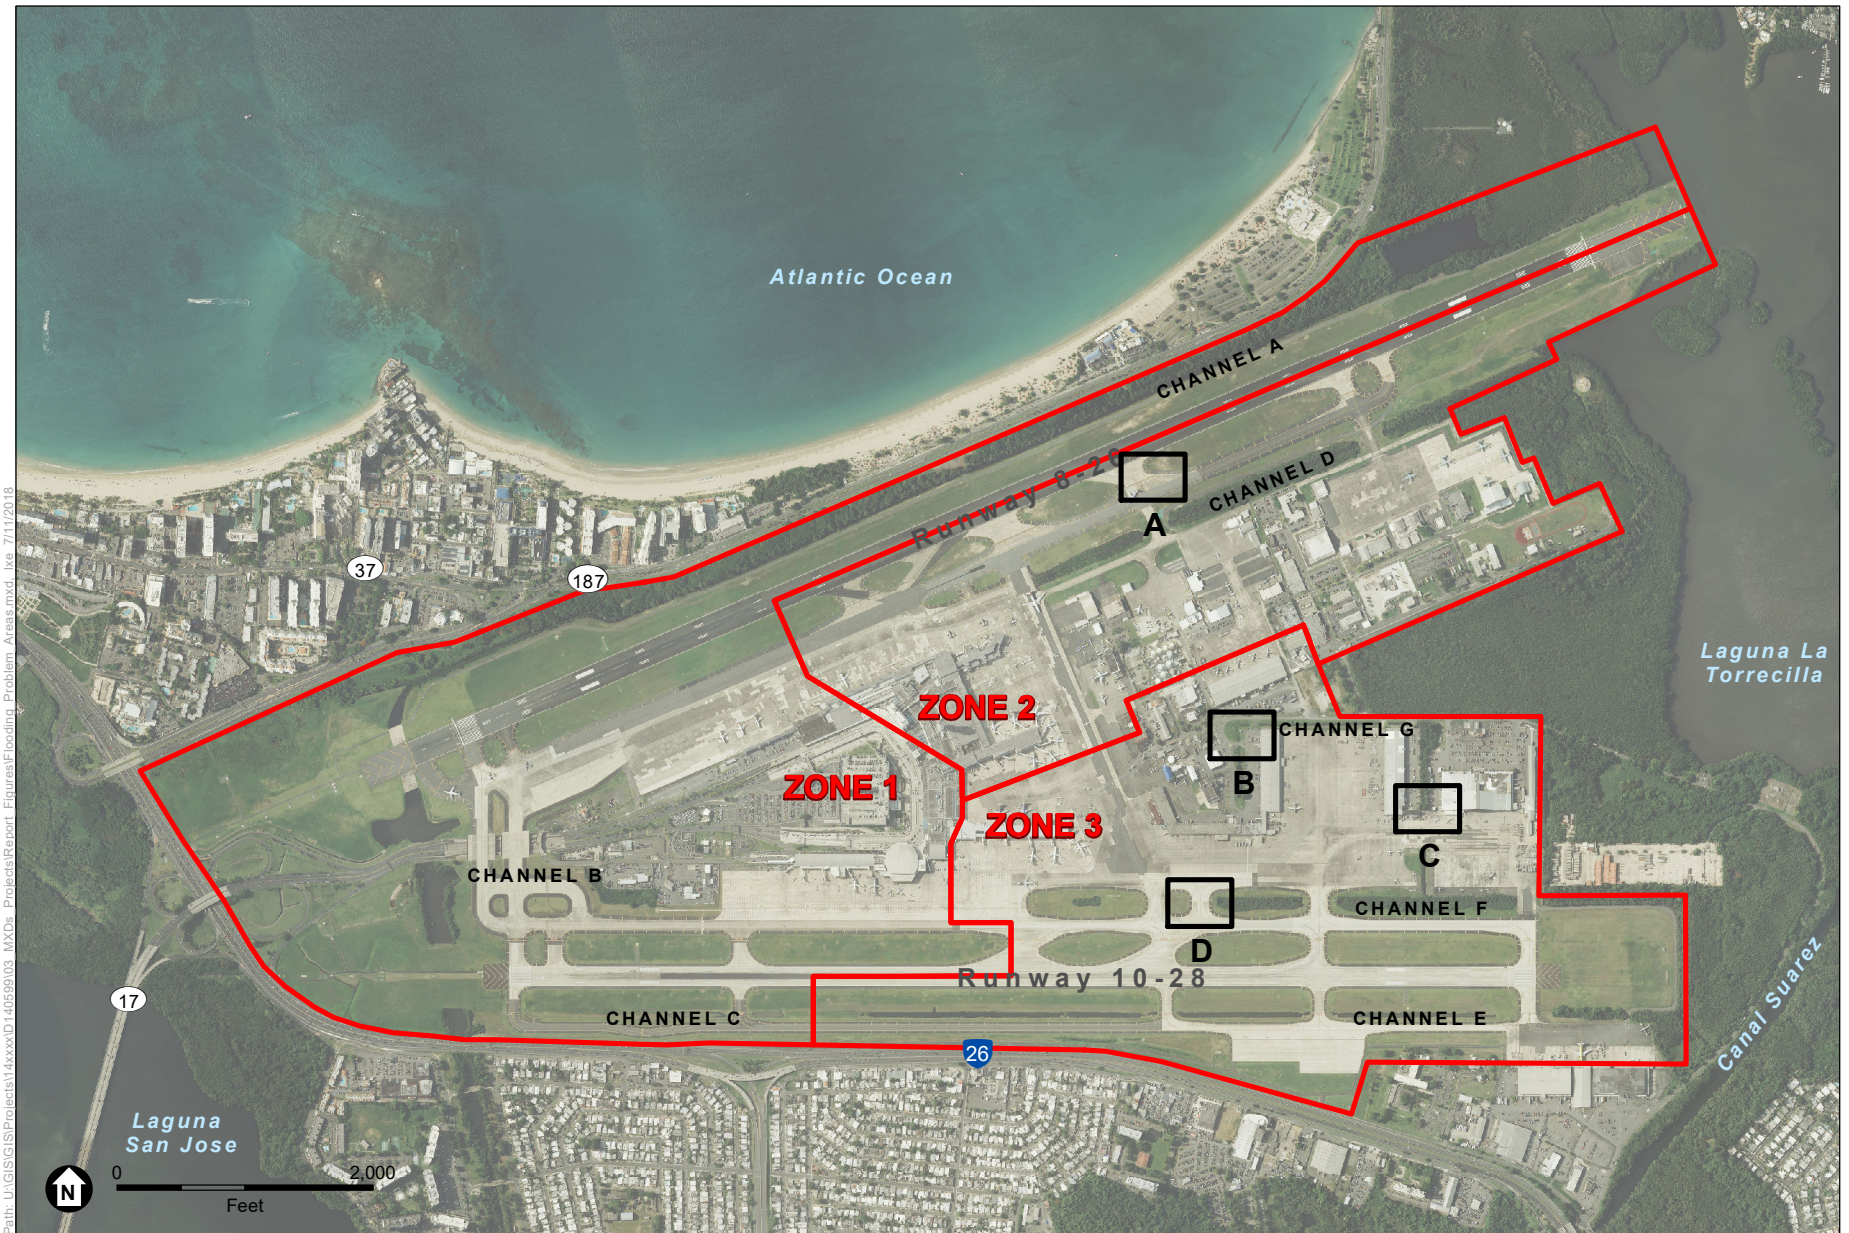
Flooding has been a persistent problem at various locations throughout the airport. Known problem flooding areas at the airport are shown in Figure 4. These areas were identified based on conversations and information provided by airport staff. Photos of historical flooding events were provided to the team by Aerostar (Photo 2 and Photo 3).

- Problem Area A is connected to the system in Zone 2. Flooding in this location results in encroachment of the adjacent runway and taxiway and can damage nearby infrastructure such as signage and lighting.
- Problem Area B is connected to the drainage system in Zone 3. The drainage channel in this area is adjacent to a sanitary sewer pump station. When flooding occurs at this location, it can inundate the pump station and cause damage to the pumping facility.
- Problem Areas C, and D are also located along the drainage system in Zone 3. Flooding at these locations can result in encroachment on adjacent taxiways and damage to nearby infrastructure including signage and lighting.

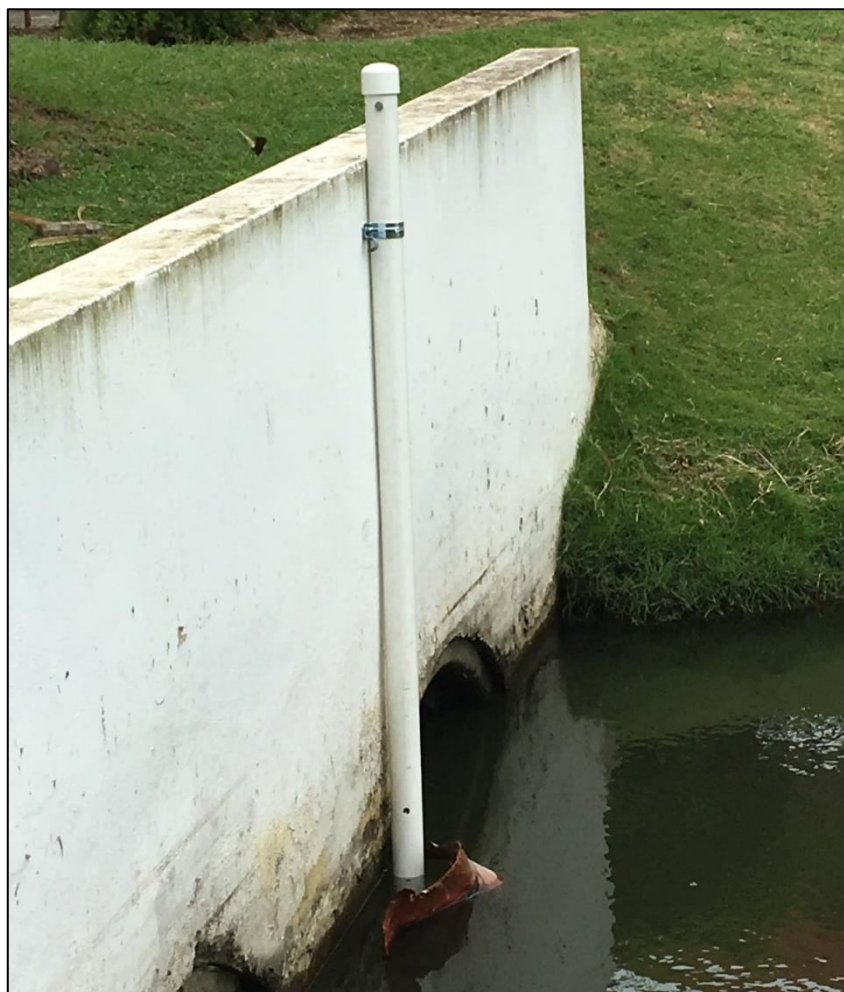
**Photo 4**  
Installed level logger.

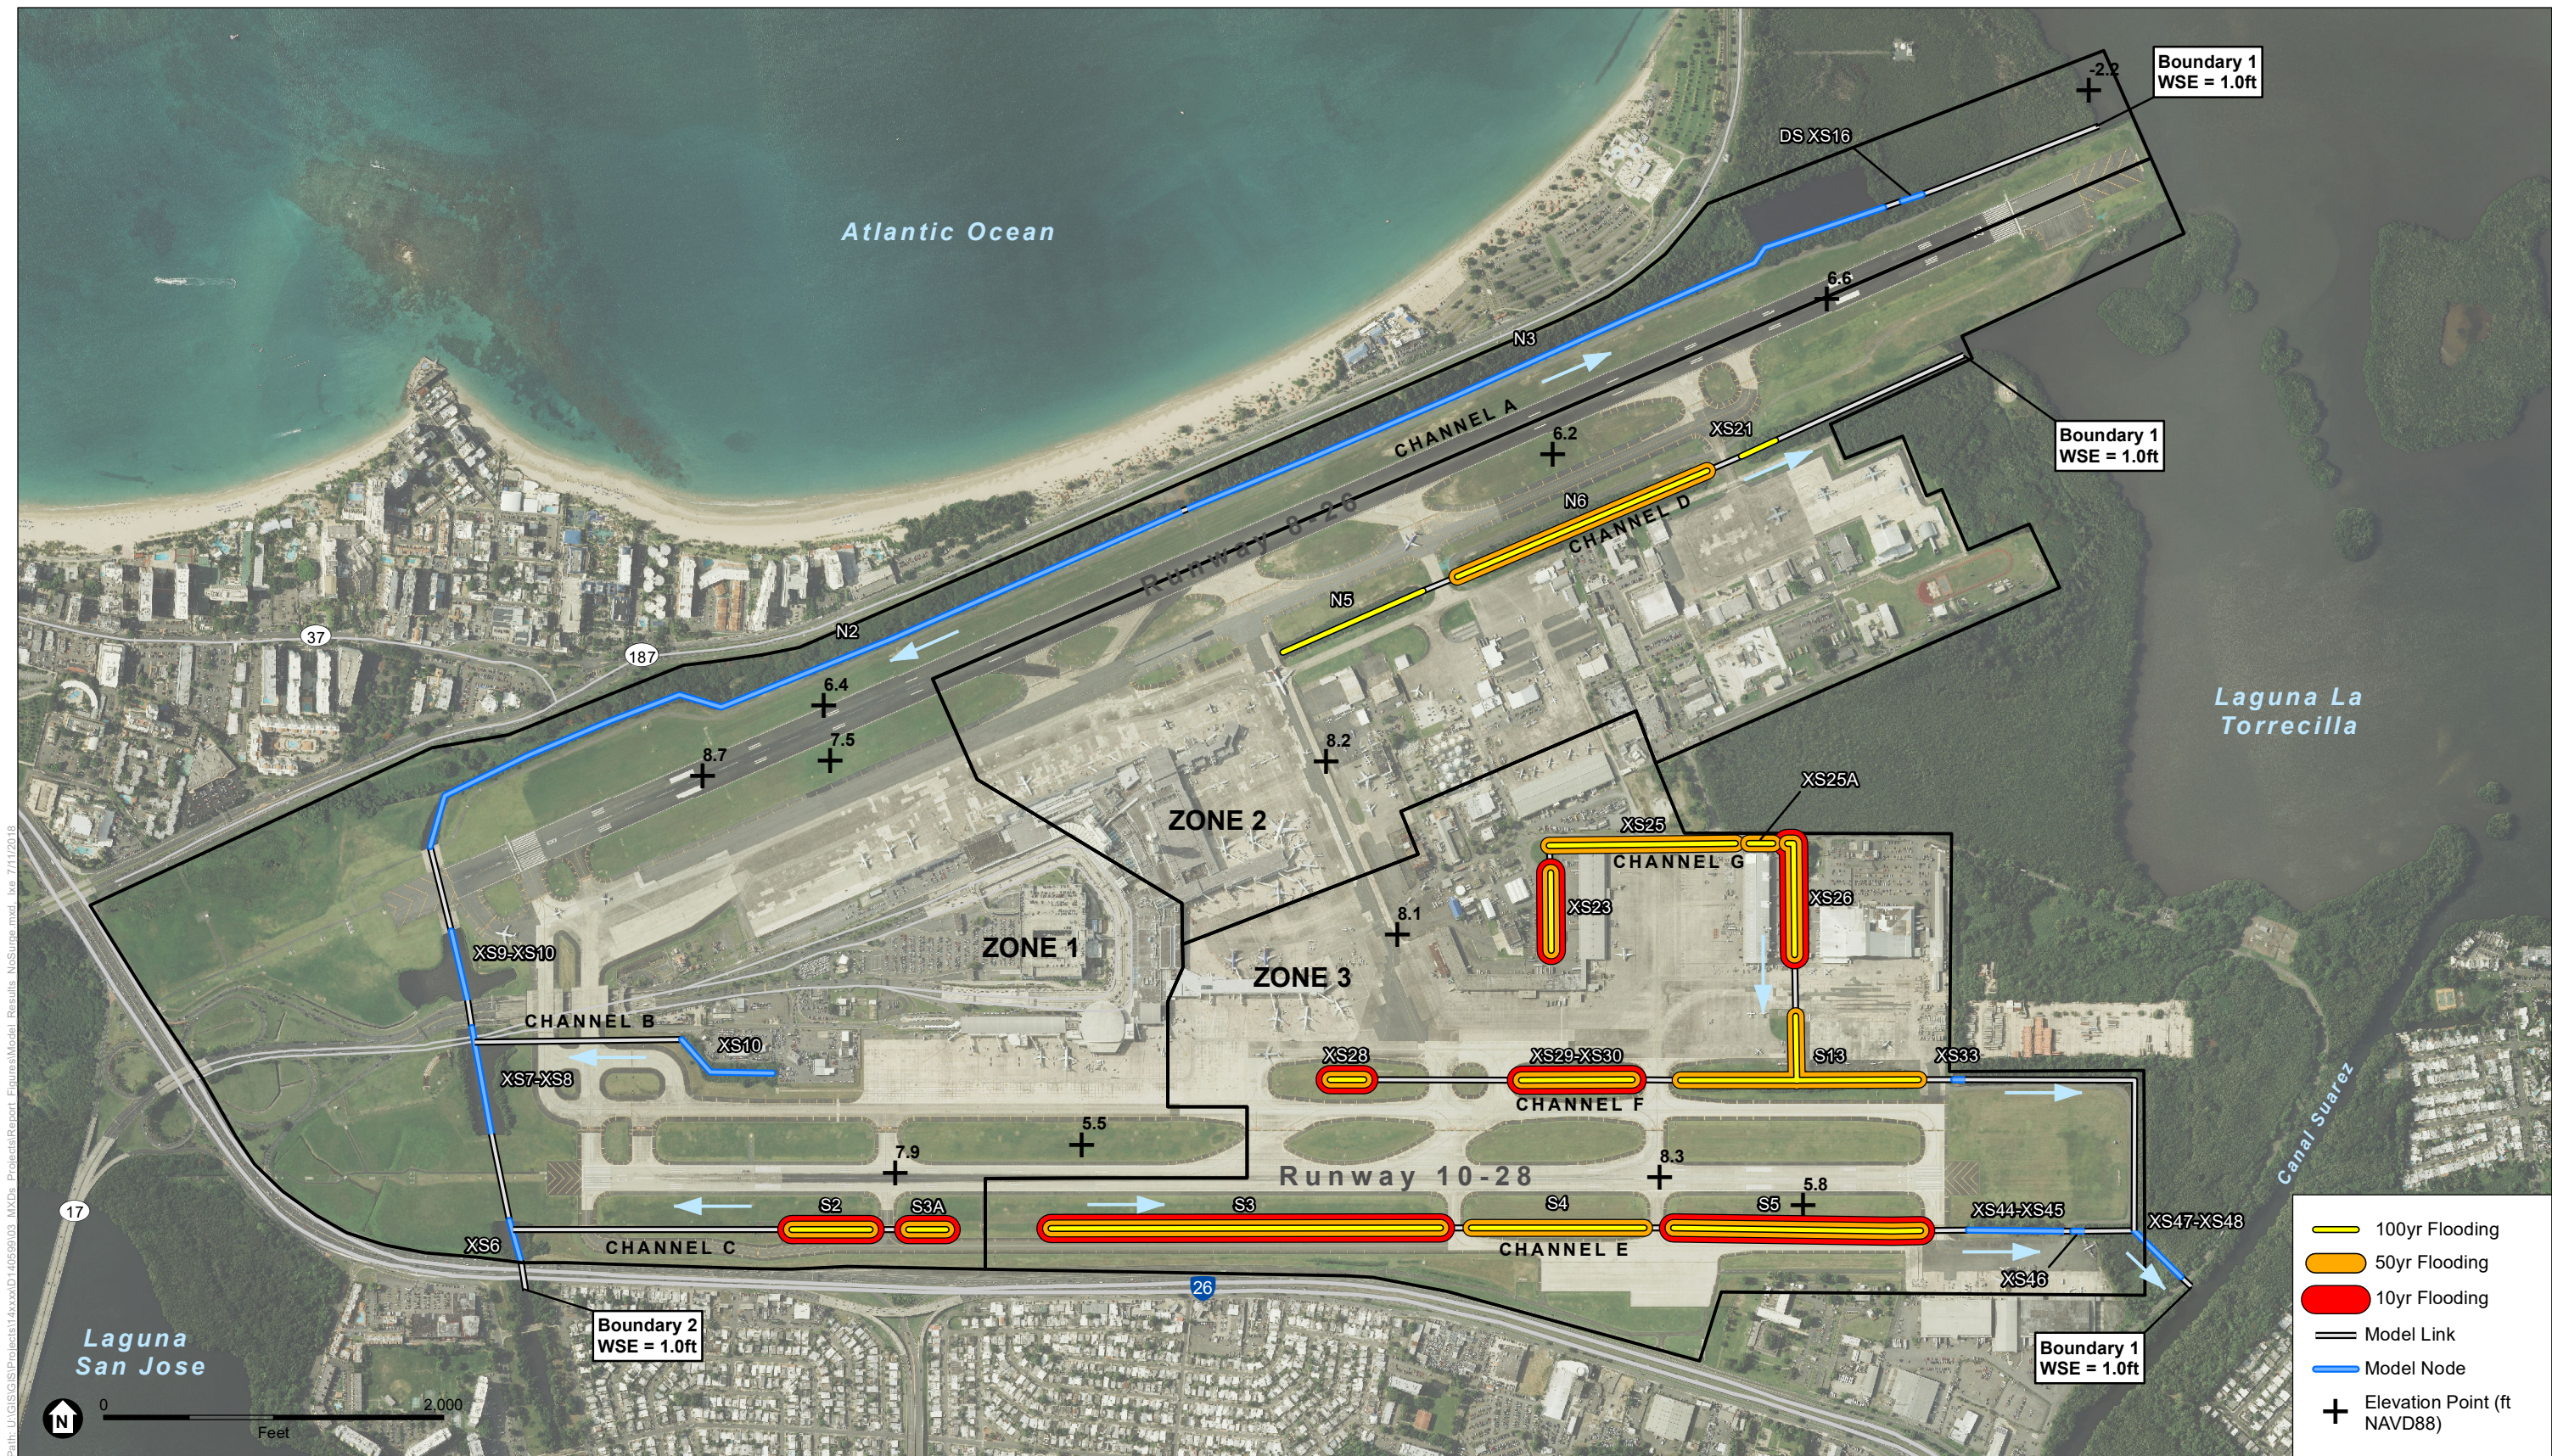
**Figure 6a**  
Model Results - Existing Conditions, No Surge  
San Juan, PR

For the no storm surge scenarios (Figure 6a) flooding is only predicted in Channel C. Flooding is predicted for Channel C for the 10, 50, and 100-year storm events.

Although Problem Area A (Figure 4) is located just north of Channel D, the model does not predict flooding during the more frequent 10-year event. This flooding is most likely the result of clogged stormwater outfalls that discharge into Channel D and were not simulated in the model.

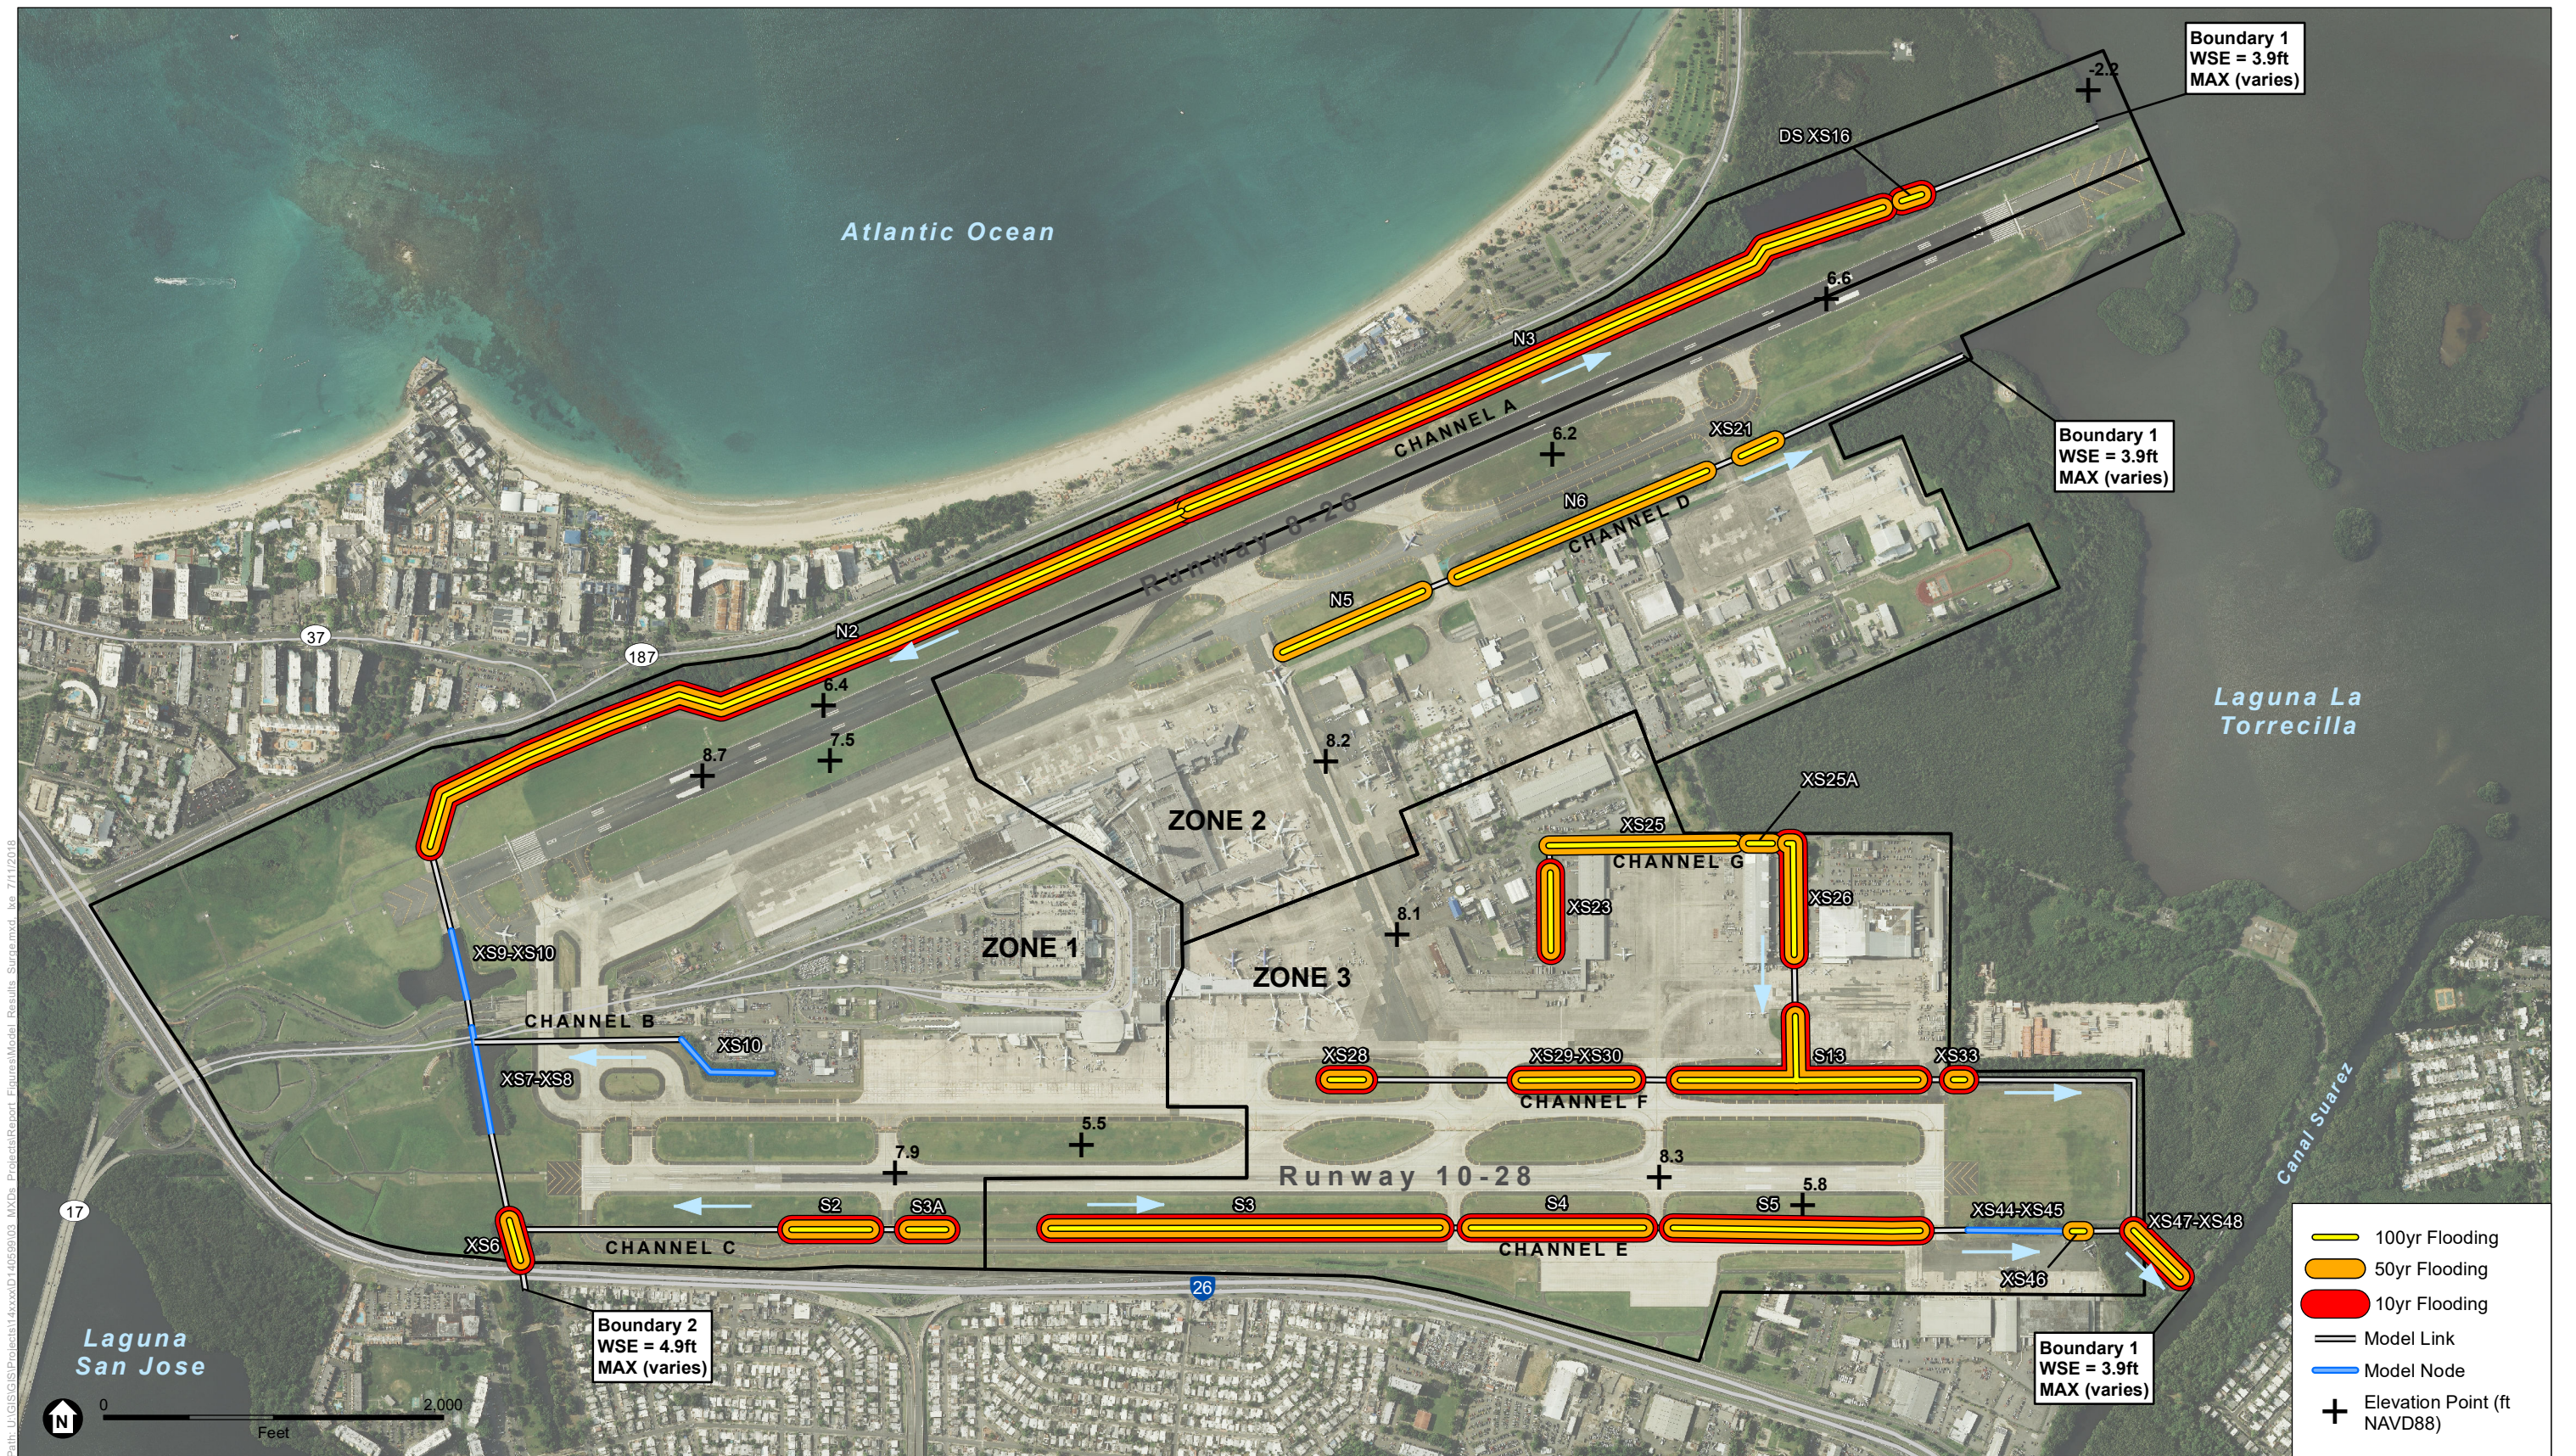
**Figure 6b**  
Model Results - Existing Conditions, Surge  
San Juan, PR

Under the storm surge conditions flooding was predicted at each node of Channel D for the 50 and 100-year rainfall events, but no flooding was predicted under the 10-year storm event.

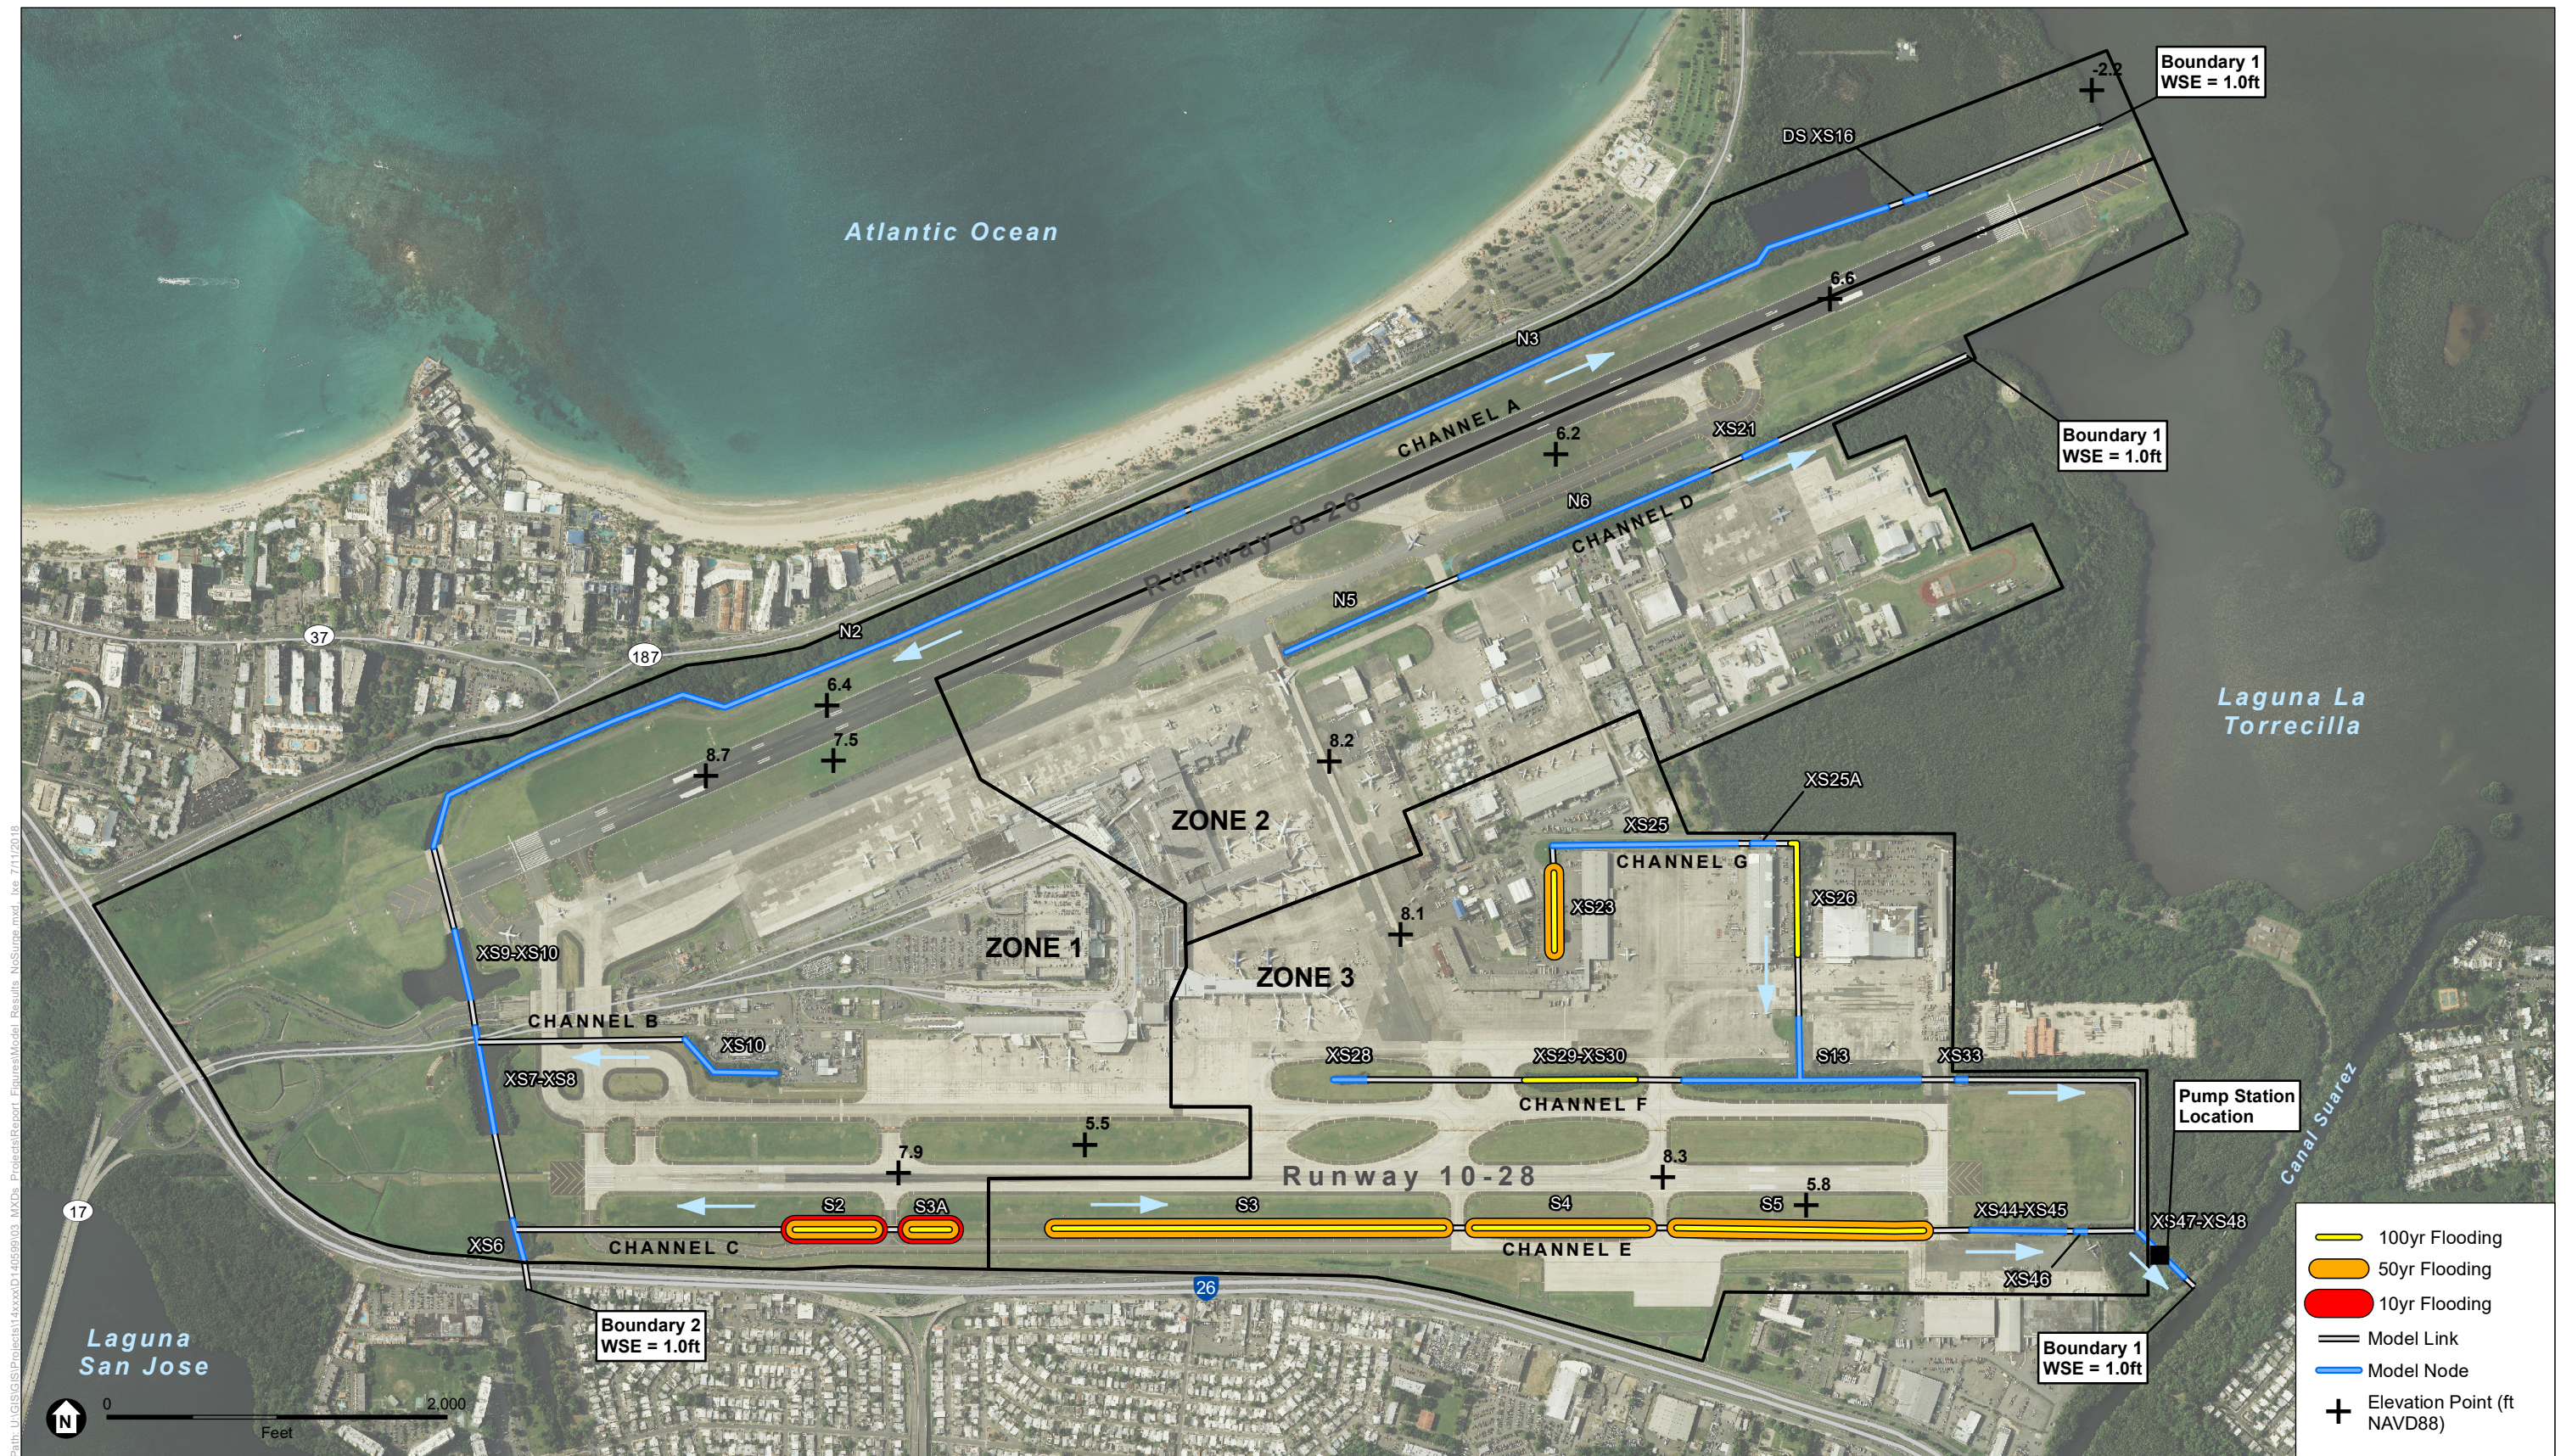
**Figure 8a**  
Model Results - Alternative A, No Surge  
San Juan, PR

Overall, drainage improvements modeled in Alternative A were sufficient to achieve flood mitigation at least to the 10-year event level at Problem Areas B, C, and D under no storm surge conditions. Under storm surge conditions, flooding persisted at all problem areas for all return interval events simulated. These results suggest that in Zone 3, drainage improvements decrease rainfall driven flooding, but storm surge conditions overwhelm the capacity of the system to effectively drain runoff from rainfall events under storm surge conditions.
